<b>The Board of Audit and Inspection of Korea</b>

## Audit Report on Safety Management of Power Supply Facilities

Disclosed on January 9, 2020

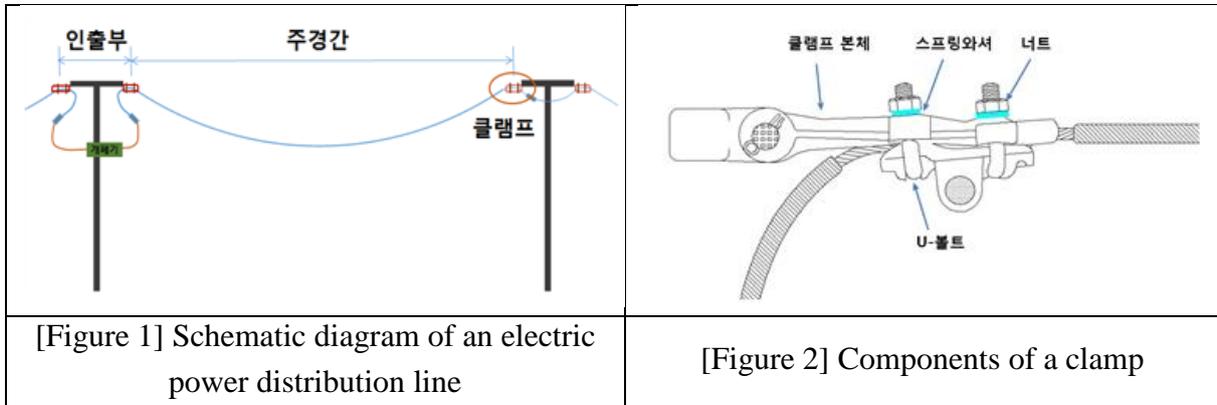
- A clamp equipped with two U-bolts and four nuts enables a presser foot to securely hold the wire.
  - Spring washers should be installed between the bolt and the nut to prevent the nuts from loosening over time.
  - Installing a clamp without the necessary nuts or spring washers can reduce its retention force, disabling the clamp from isolating the transmitted vibration to it and, in the long run, causing the wires to break.
- Though KEPCO stated in its guidelines ("Distribution Line Inspection Guidelines") that defective clamps should be inspected, it has not included any details on how to inspect and check the overall condition of the clamps.
  - It was found that KEPCO workers failed to properly check to see if the clamps had been correctly installed.
- During the audit period, the BAI analyzed photos taken by KEPCO Sokcho

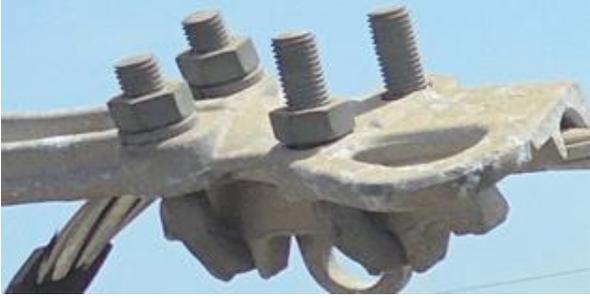
<p>Special inspection conducted by KEPCO (May 15, 2019)</p>	<p>Audit conducted by BAI (September 9, 2019)</p>

- KEPCO failed to recognize that there were at least 16 electric poles with clamps that were defective due to missing spring washers or nuts, and as such, the clamps were neglected and left unfixed.
- In September 2019, the BAI conducted an additional inspection on eight out of 16 randomly selected electric poles. All eight electric poles were found to have problems with faulty clamp installation.

A case where a clamp was left unattended with a nut and two spring washers missing (found during the inspection conducted in May 2019)

The BAI recommended the CEO of KEPCO to inspect the retention force of the installed bolted type dead-end tension clamps and their fastening condition, and to replace or repair clamps that are faulty. For the distribution lines, the BAI requested KEPCO to pay meticulous attention to their construction, maintenance, and management in the future.
